StingerCE Quick Fix Bulletin

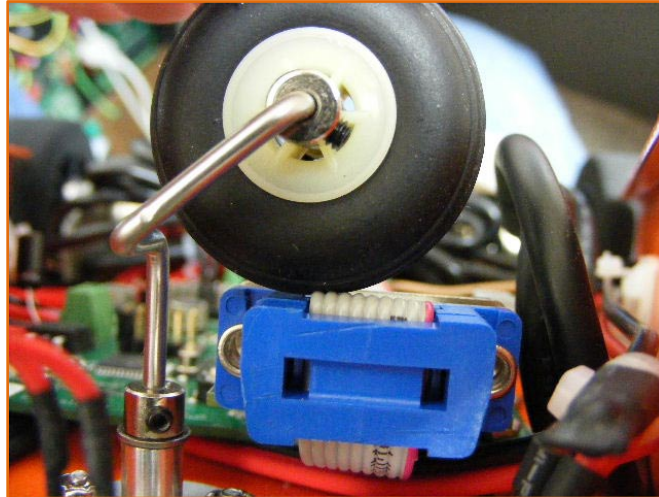
Please note that there is very little clearance between the Stinger CE's rear caster wheel, and the Serializer RS-232 module/serial cable. Sometimes, the wheel can make contact w/ the Serial cable connected between the RS-232 module and the eBox-2300.

To provide adequate clearance, please follow these steps:
